**Determination: Soil sampling, USTs****PA/VSI Or RFA FILE REVIEW CHECKLIST**

Facility Name: Kvaerner Songer (Penmark Associates, Ltd.)

EPA ID: MID 005 341 979\_\_\_\_ City: 2219 Chapin Jackson, Jackson Co.\_\_\_\_ State: MI\_\_

**Technical Enforcement Support  
at Hazardous Waste Sites  
Zone III  
Regions 5,6, and 7**

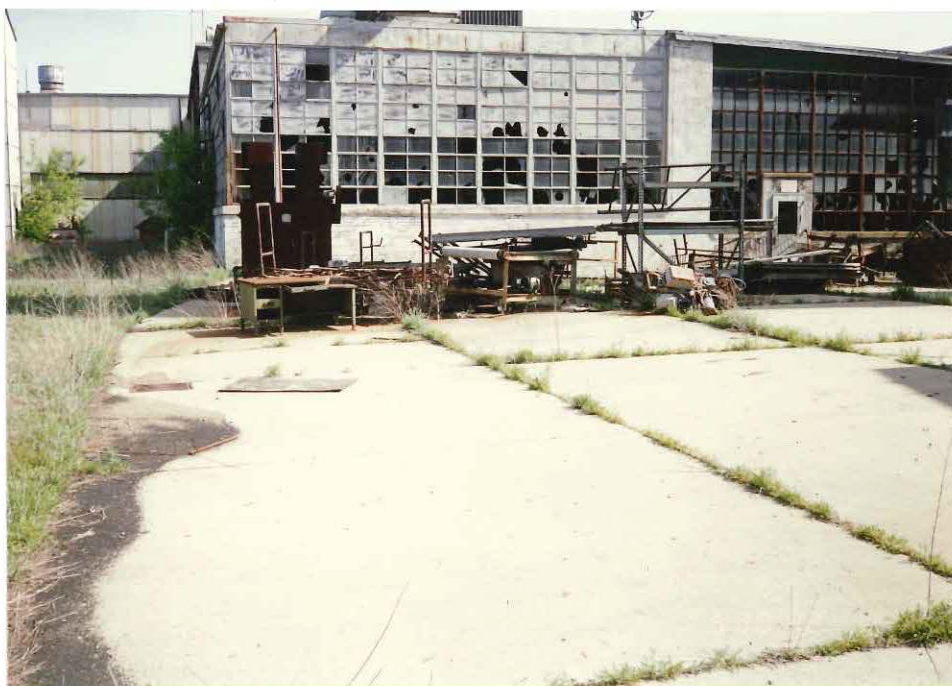
**Photograph No. 1**

The pad was covered with rusted debris. There was no sign of any waste still being stored on site. No odors were detected. A sign was posted reading, "No smoking within 50 feet - inflammable solvents." The concrete area appeared to be larger than 6-feet by 30-feet. PRC estimated the area to be about 20-feet by 60-feet.

SWMU 2 was cluttered with rusted steel debris. There was no sign of any waste remaining at the SWMU. No odors were detected. The floor had a few small cracks.

**Location:** SWMU 1 and SWMU 2

**Recommendations:**              PRC recommends that Goodyear collect soil samples from the area around the concrete pad. The samples should be analyzed for VOCs.

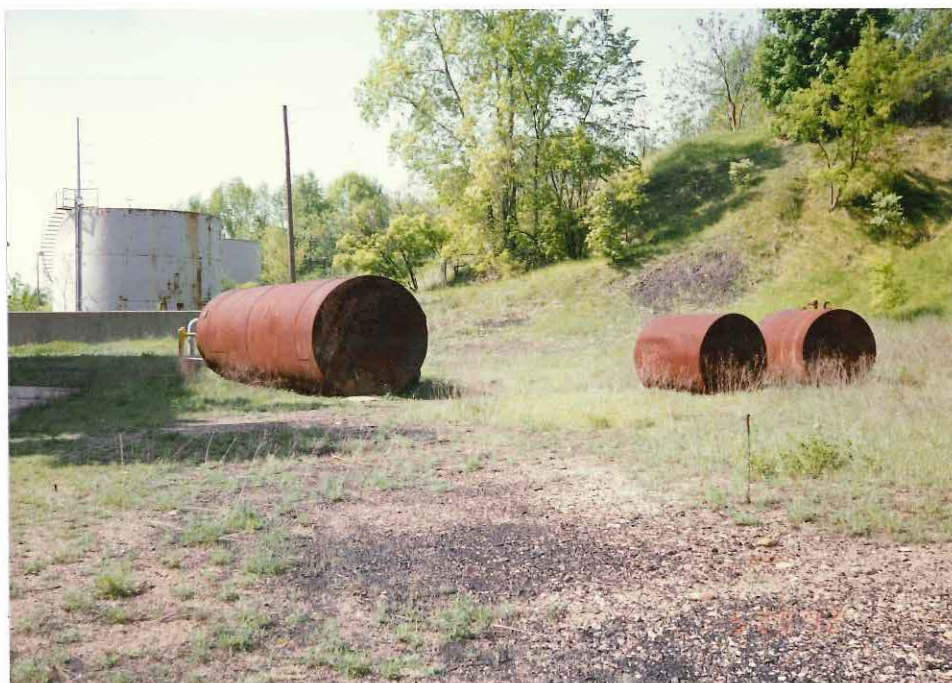
**Photograph No. 2**

Facility records indicate that four USTs existed at the facility. Two 15,000-gallon USTs contained deodorized gasoline. There was also a 10,000-gallon fuel oil UST and a 1,000-gallon gasoline tank (MDNR, 1992). During the VSI, five tanks were observed (see Photographs No. 2 and No. 3). The sizes appeared to match the sizes in the facility records. The fifth tank appeared to have a 1,000-gallon capacity. Penmark representatives stated that the tanks had been removed at the time Penmark bought the property in 1984. The tanks appeared to be in good condition, considering that they were pulled and have been left aboveground since at least 1984. Small holes were evident in some of the tanks. It is impossible to know if the tanks had holes while they stored raw material, if the tanks were damaged when they were removed, or if the tanks had rusted while aboveground. Goodyear has no record of the tank removals in its files. However, the facility closure plan stated that all tanks were flushed, vented, and had all sludges removed (Goodyear, 1984b). Goodyear facility representatives were unable to locate information concerning the former locations of the USTs (Goodyear, 1992).

**Location:** AOC 1

**Recommendations:** Because the exact former locations of the five USTs are unknown, PRC recommends soil gas sampling for VOCs at AOC 1. If the soil gas sampling indicates any areas of VOC contamination, more extensive soil and ground-water sampling may be necessary.

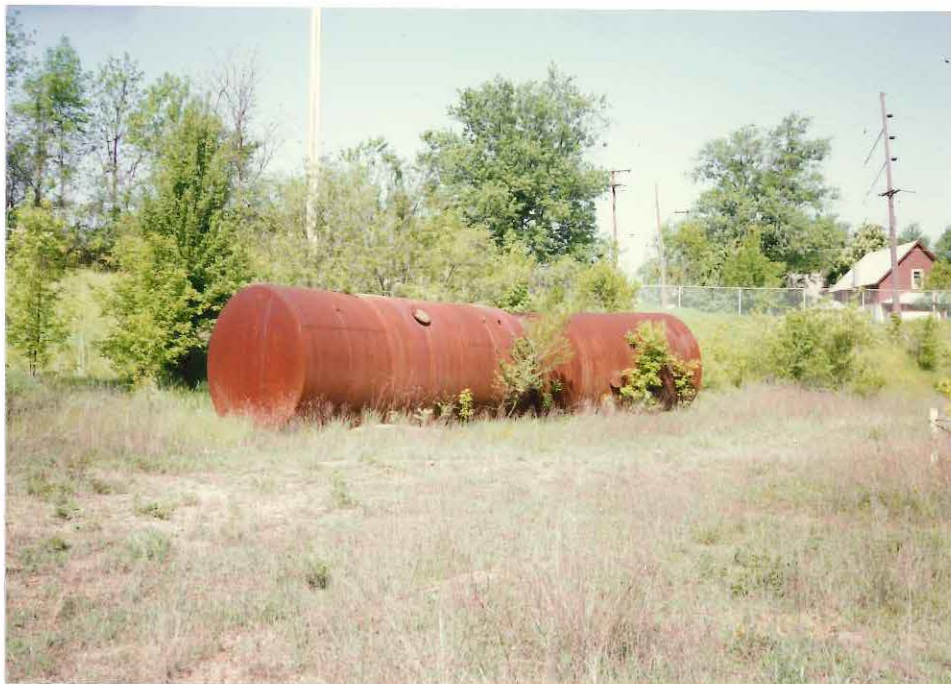
**Photograph No. 3**

**Location:** AOC 1

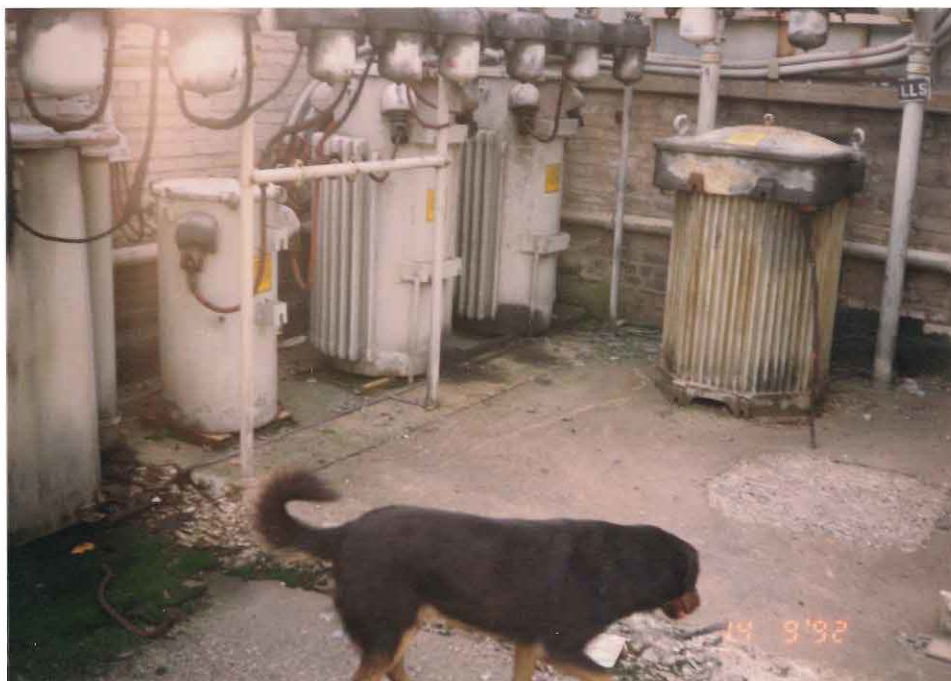
**Photograph No. 4**

Transformers No. 1 through No. 5 are located outdoors on a concrete pad (see Photographs No. 4 and No. 5). All five of these transformers were marked with yellow caution stickers stating that the transformers contained oil with 50 to 499 parts per million PCBs. Three other transformers were located on the same pad, but these units had blue stickers stating that PCBs were not present in the transformer oil. Because none of the outdoor transformers had oil level indicators, PRC could not determine whether oil remained in the transformers. Dark, oily stains were present around the bases of Transformers No. 2, No. 3, and No. 5 (see Photographs No. 4 and No. 6). The concrete pad was not diked. The concrete was

cracked in several areas. Bare ground is present about 10 feet from the transformers. The manufacturer's labels on the units were corroded and could not be read.

**Recommendations:** PRC recommends that Penmark properly dispose of all PCB-Contaminated Transformers. Because none of the transformers has been used since 1984 and because Penmark has no plans to use the transformers in the future,

Penmark should properly dispose of them. In addition, wipe and soil samples should be collected around the bases of all PCB-Contaminated Transformers to determine the extent of any PCB-contaminated transformer oil leakage.

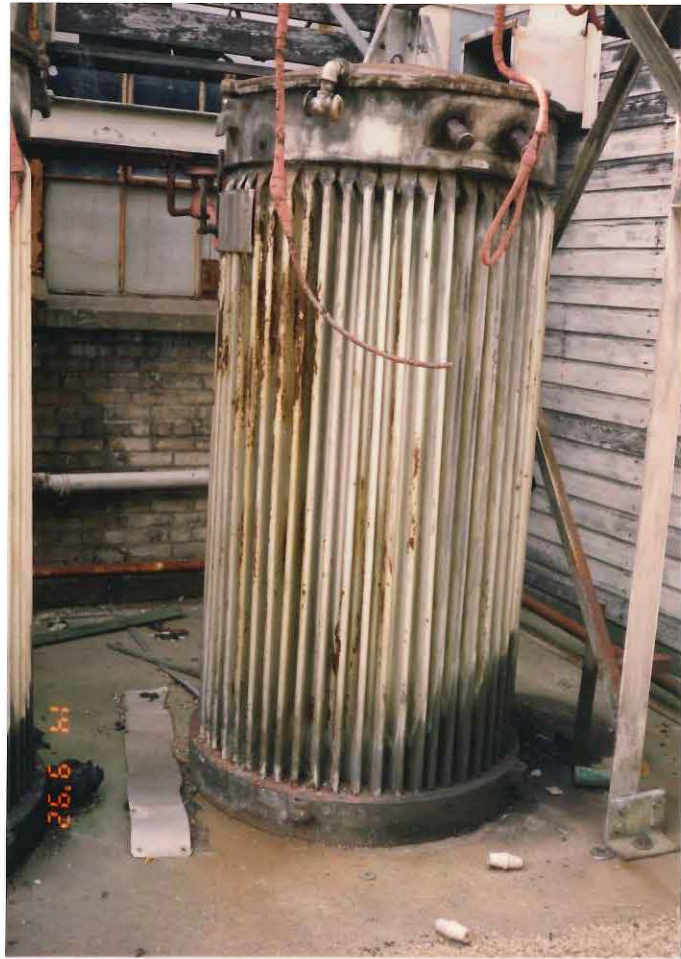
Photograph No. 5  
Location: AOC 2  
Orientation: Northwest  
Date: September 14, 1992  
Description: This photograph shows Transformer No. 5. A yellow label indicating that the unit contains PCB-contaminated oil is on the back side of the unit. A dark oily stain can be seen around the base of the transformer.

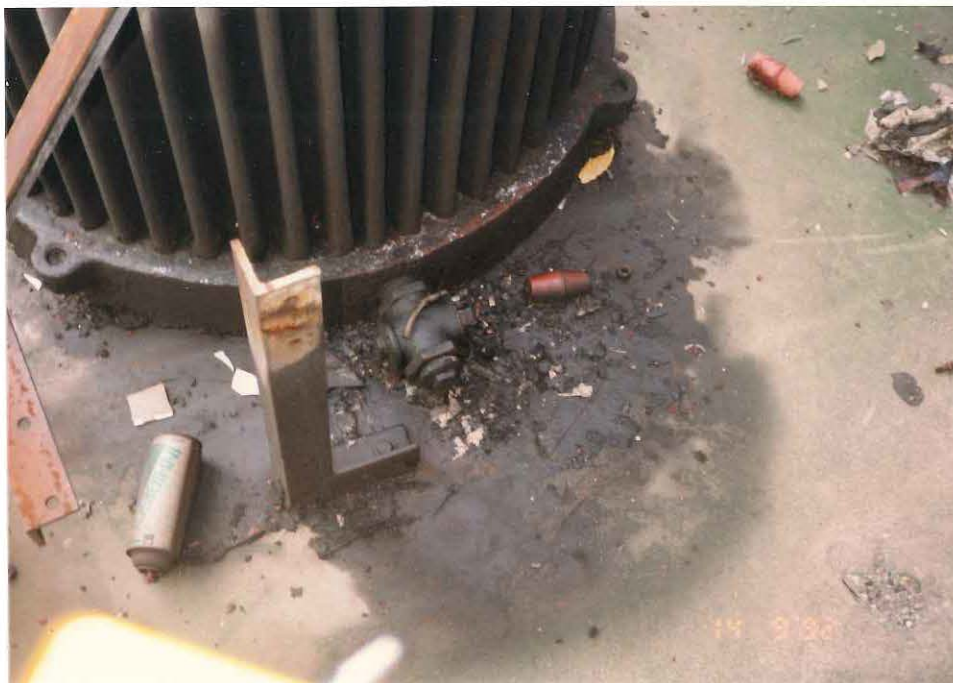
Photograph No. 6  
Orientation: South  
Date: September 14, 1992  
Description: This photograph shows the stain around the base of Transformer No. 5.

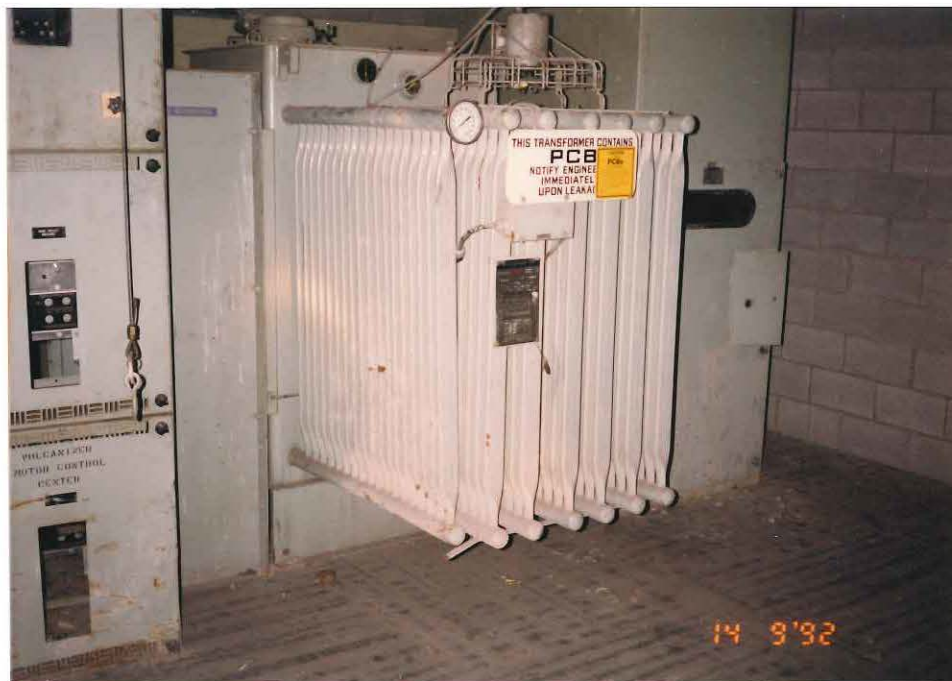
**Photograph No. 7**  
**Orientation:** Northwest  
**Description:** This photograph shows Transformer No. 6.

PCB-Contaminated Transformers No. 6 and No. 7 were located on the second floor of the west side of the facility building (see Photographs No. 7 and No. 8). These units were located on concrete flooring with no cracks. A valve was located near the base of each unit. A pan of oil dry was located beneath the valve of each unit. No stains or leaks were visible around either of the units. A liquid level indicator on Transformer No. 7 showed that the unit was one-third to one-half full of transformer fluid. Because the transformers have not been used since 1984, the accuracy of the indicator is questionable.

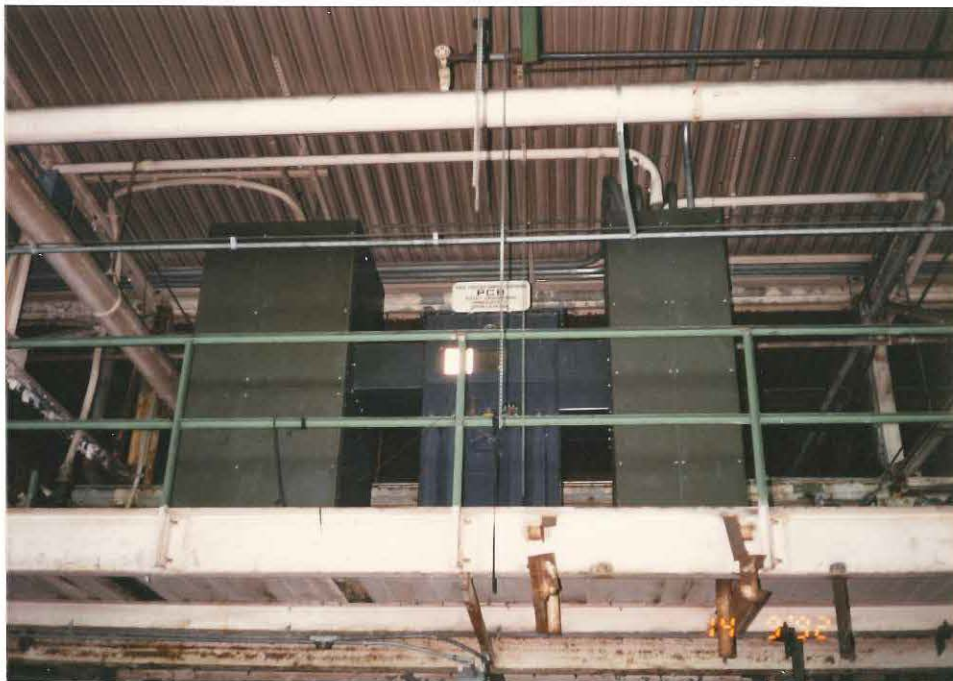
Photograph No. 9  
 Orientation: West  
 Description: This photograph shows Transformer No. 8.

Transformer No. 8 was suspended from the ceiling indoors on the eastern side of the facility building. The unit rested on a steel and wood platform (see Photograph No. 9). No leakage was detected on the underside of the platform. Cracks were evident in the concrete of the first floor below the transformer platform.

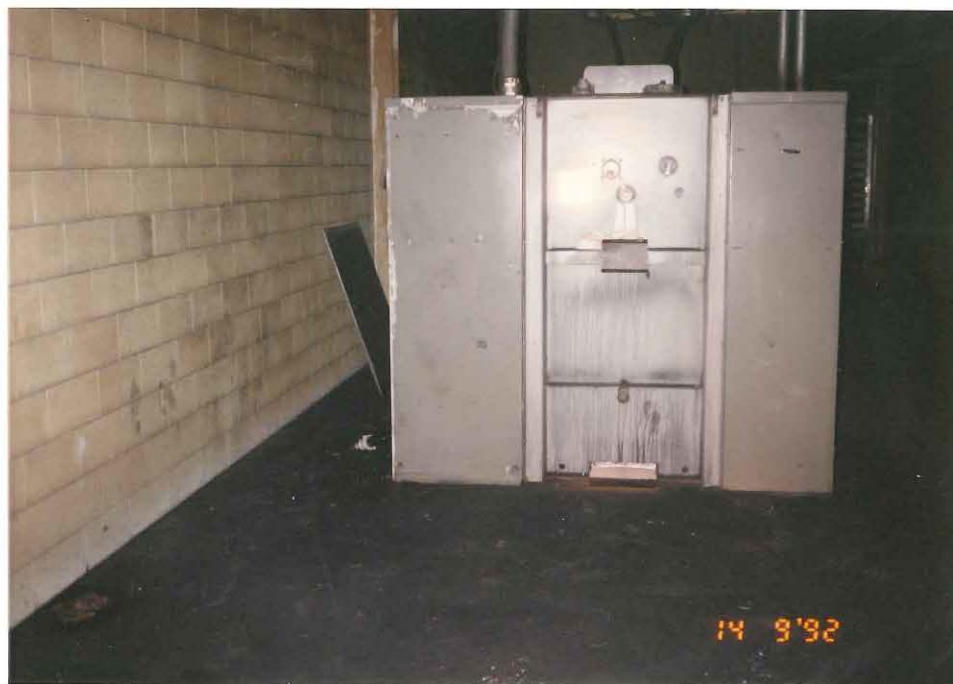
Photograph No. 10  
 Orientation: West  
 Description: This photograph shows Transformer No. 9.

Transformers No. 9 and No. 10 were located on the second floor of the eastern side of the facility building. No cracks were visible in the concrete flooring. Each transformer had a valve near the bottom of the unit. A small pan of oil dry had been placed below the valve of each unit. Dark, oily stains were present on the floor around the pan at Transformer No. 10; the oil dry in the pan also appeared oily and discolored. The liquid level indicators on both units indicated that the transformers were about one-half full. Manufacturer's labels indicated that each transformer had an oil capacity of 330 gallons.

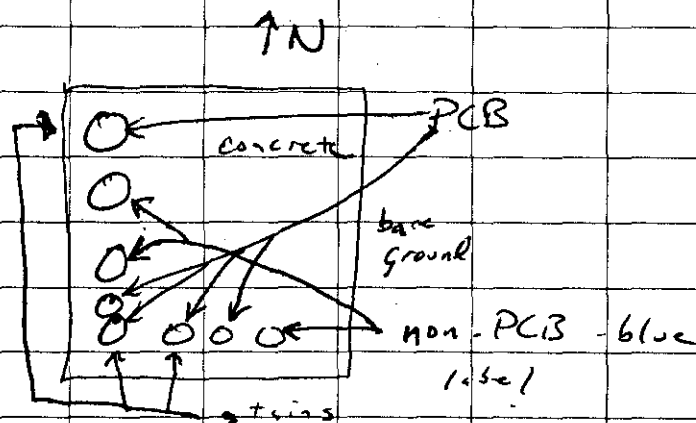
Outdoor transformers

locks or at least dark

stains around 3 transformers
